There is general agreement that the immediate cause of the Crandall Canyon mine disaster was a large coal bump that occurred on the morning of August 6, 2007. Coal bumps, which are sudden, violent failures of highly stressed coal, have been a longstanding safety hazard in some mines in the Southern Appalachian, Colorado and Utah coalfields. Typically, bumps can occur when the roof and floor strata are strong and the mines are under deep cover. Bumps have caused many fatalities in past decades, and were the subject of intensive research by NIOSH and its predecessor agencies. The results of this research were transferred to the mining community, and much of it can be found at the NIOSH mining website. A landmark document describing the results of the research effort is Special Publication 1995-01, which is still considered the fundamental resource on the evaluation and control of bumps.

NIOSH has used ARMPS to evaluate, retrospectively, the complete sequence of events leading up to the bump on August 6. It must be noted, however, that the official investigation of the disaster at the Crandall Canyon mine has not yet been completed, so the data currently available for analysis is inc

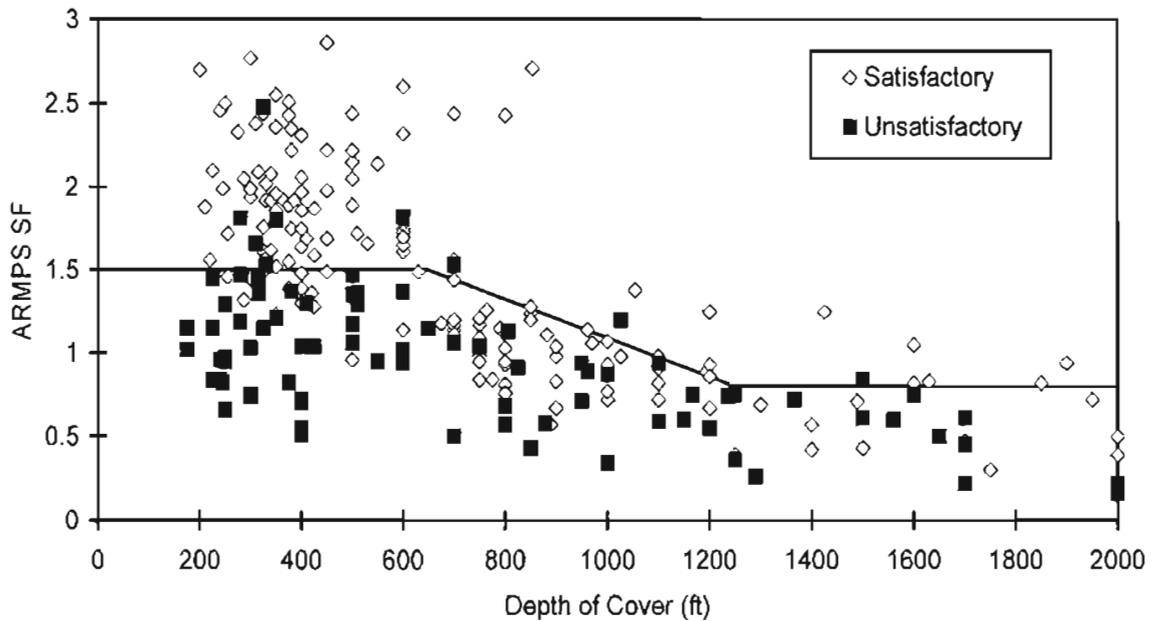
Table 1, which was published with the 2002 paper and subsequently included in the ARMPS help file the complete suggested SF guidelines. In addition, figure 3 illustrates the pillar SF values observed in the data base, while figure 4 shows the importance of the BPSF.

Figure 3. The ARMPS case history data base, including deep cover cases, and showing the suggested pillar SF.

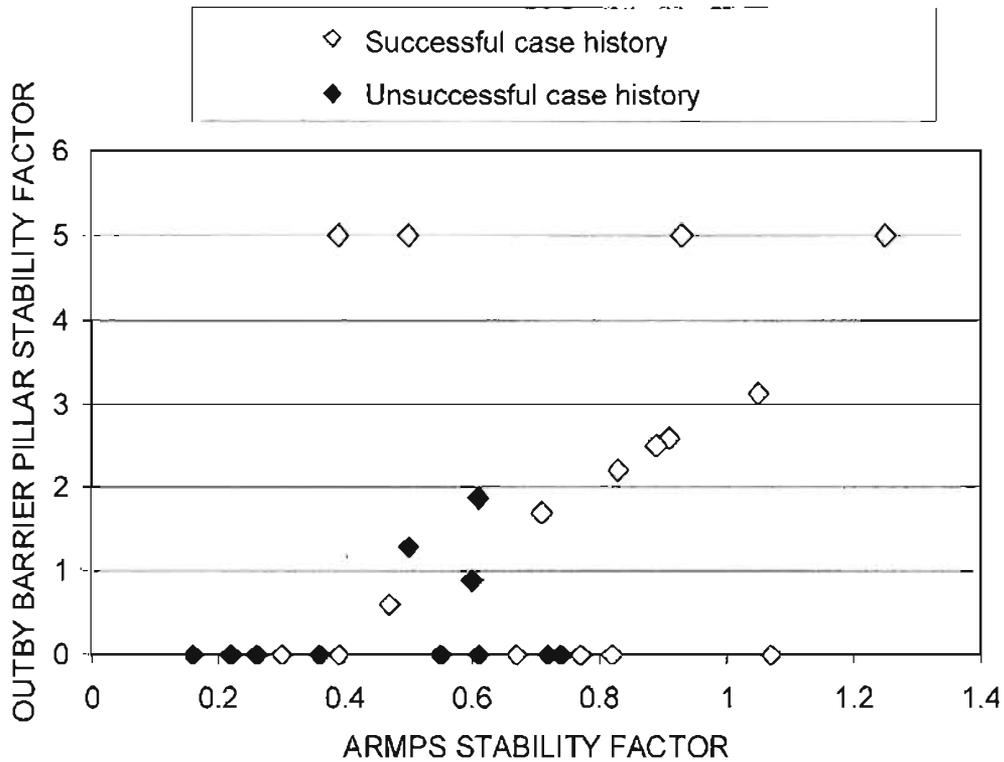
“Only one failure (out of 12 cases) occurred when the ARMPS SF was greater than 0.8 and the barrier pillar SF (BPSF) was greater than 2.0. Conversely, 30 case histories had an ARMPS SF less than 0.8 and a BPSF less than 2.0, and 60% of these cases were failed designs. Of these 18 failed designs, 13 were bump events. In addition, every bump case history collected had a BPSF of less than 1.9.

Figure 4. The ARMPS deep-cover, strong roof data base, showing the importance of using barrier pillars for stability. Most of the unsuccessful cases are bumps.

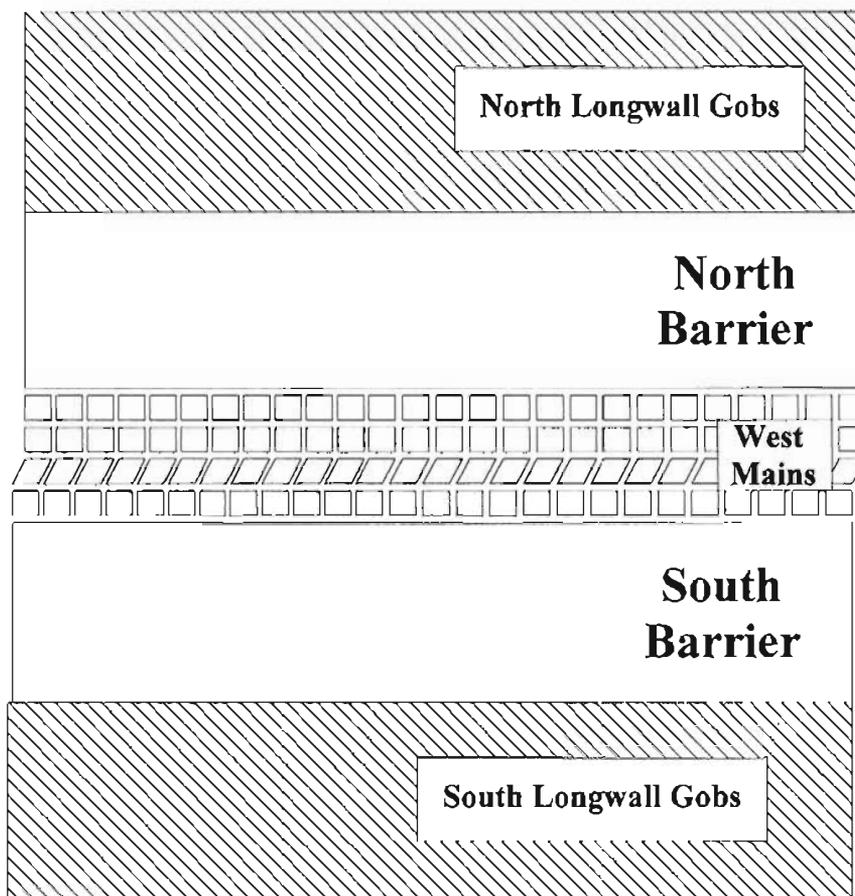
Figure 6. West Mains development as modeled in the NIOSH ARMPS analysis.

Figure 6 shows the initial situation before any mining in the North Barrier. The 70 by 70 ft pillars in the mains have an SF of 0.93, which the NIOSH guidelines suggest should be adequate

for the 2,000 ft maximum sustained depth of cover. The pillars are shielded from the extensive longwall gobs to the north and south by 450 ft barrier pillars whose BPSFs are approximately 4.4.

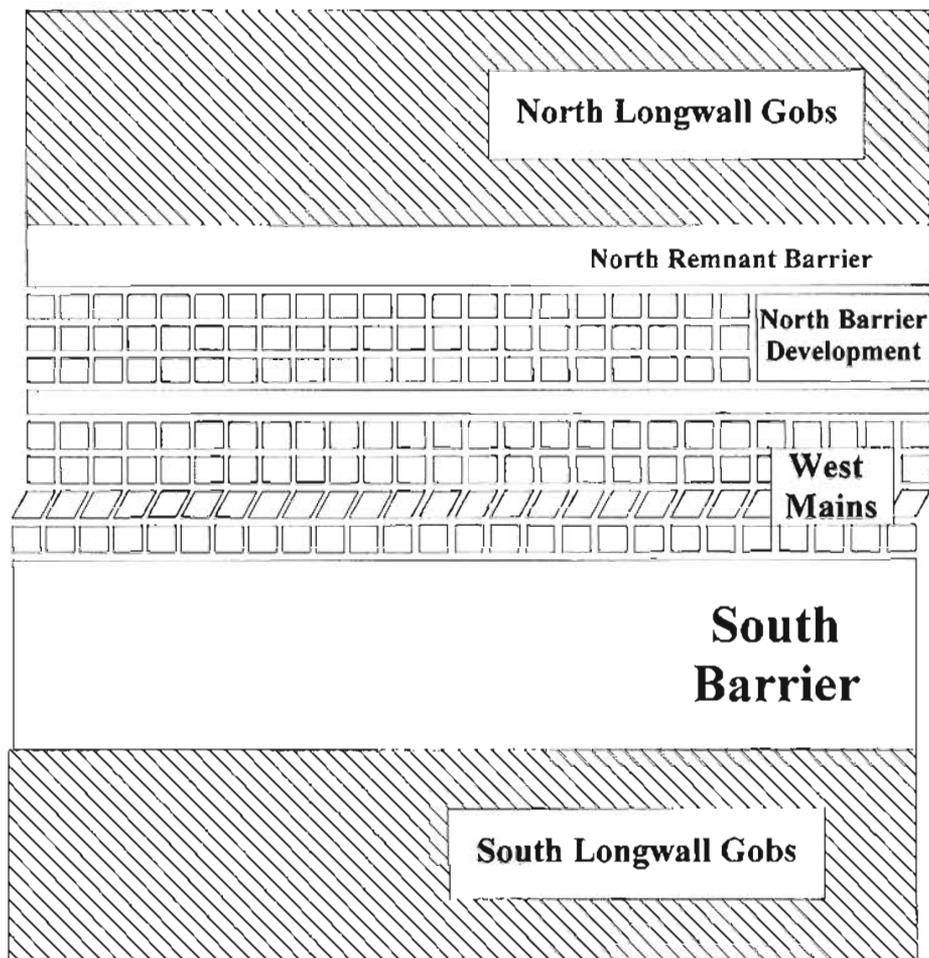
Figure 7. North Barrier development as modeled in the NIOSH ARMPS analysis.

In figure 7, development has been completed in the North Barrier. The analysis assumes that the pillars in the mains are carrying their full load and are not transferring any to the pillars in the North Barrier development. However, significant abutment load from the north longwall gobs is being transferred across the Remnant North Barrier, resulting in an ARMPS SF 0.46 for the 63 by 73 ft pillars. Most important, the BPSF for the 130 ft wide remnant barrier pillar is just 0.95.

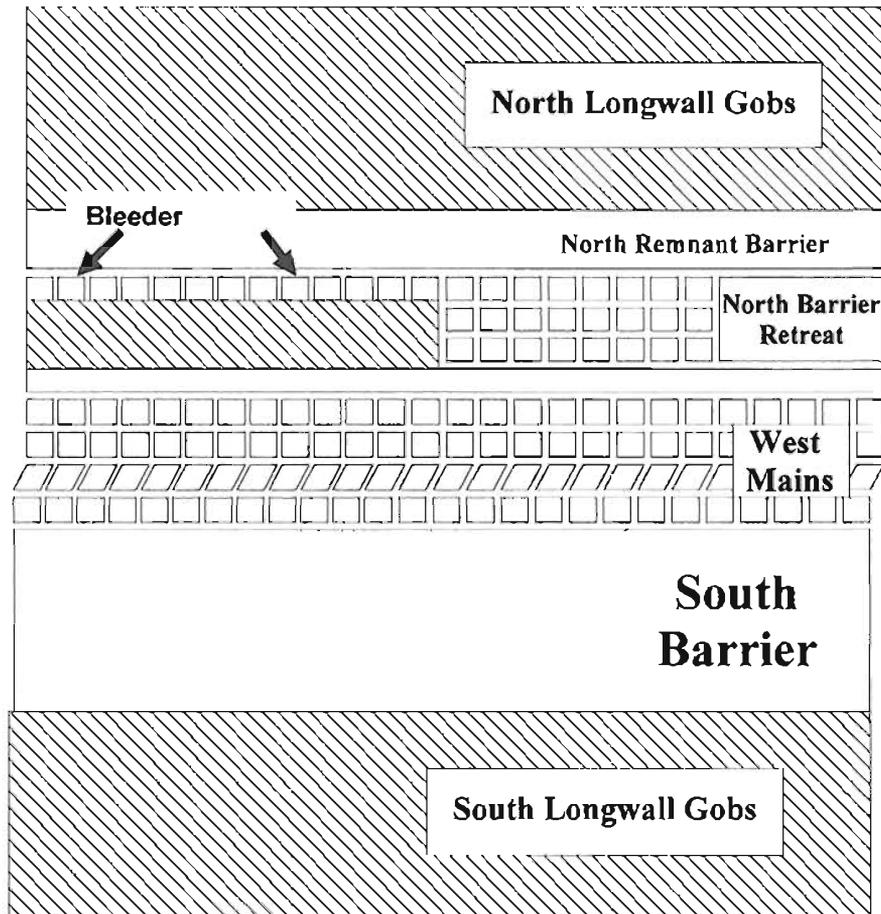
Figure 8. North Barrier retreat mining as modeled in the NIOSH ARMPs analysis. (the model assumes that the row of bleeder pillars has yielded and shed its load).

Retreat mining in the North Barrier does not affect the BPSF, but it further reduces the SF of the pillars to 0.32.³ This was the situation when the bump occurred in early March of 2006 that resulted in the abandonment of the North Barrier pillars (figure 8).

³ The NIOSH analysis presented in the text treats the row of bleeder pillar as if it was extracted with the other two pillar rows. An alternative analysis, using an “effective barrier pillar width” of 160 ft with two rows of extracted pillars, has little effect on the pillar SF but increases the BPSF to 1.17.

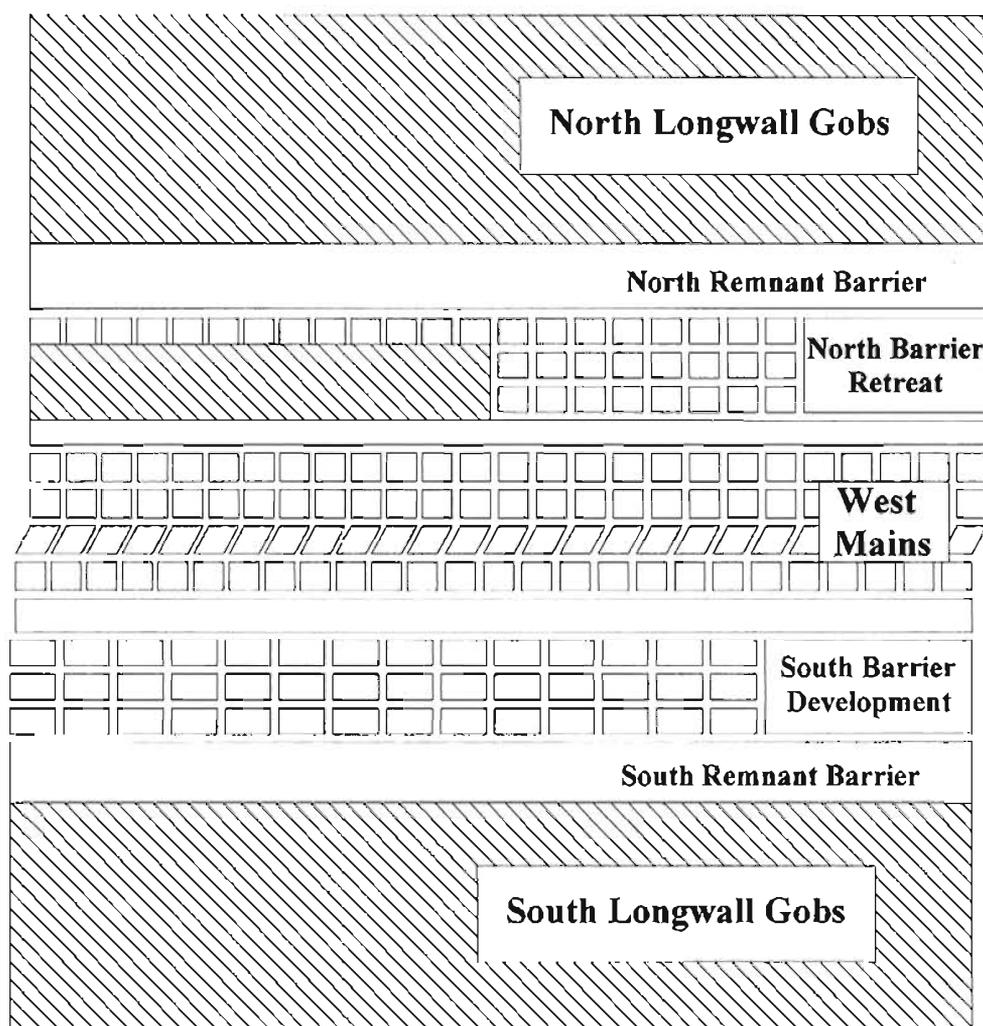
Figure 9. South Barrier development as modeled in the NIOSH ARMPS analysis.

The development in the South Barrier created pillars that were about 50 ft longer than the ones that had been used in the North Barrier (figure 9). The change increases the pillar SF by only about 15%, to 0.52, because the strength of a coal pillar is largely determined by its least dimension. The remnant south barrier pillar is 10 ft narrower than the one in the north, however, so its BPSF is estimated at 0.91. Pillar recovery, which in the South Barrier involved a slab cut into the remnant barrier, would have further reduced both the pillar SF and the BPSF. Pillar recovery never progressed into the deepest cover portion of the panel, however.

One other consideration in evaluating the South Barrier is the potential for load transfer resulting from failure of pillars in the original West Mains. Once the pillars in the North Barrier have been extracted or failed, an abutment load can be transferred across the slim 50 ft pillar that separates the North Barrier Development from the West Mains. Under these circumstances, the SF for the mains pillars is reduced to 0.71, while the BPSF for the 50 ft barrier is just 0.74. Failure of the pillars in the mains could ensue, and it would result in a second side abutment being applied to the pillars in the South Barrier, further reducing the pillar SF there to 0.35.

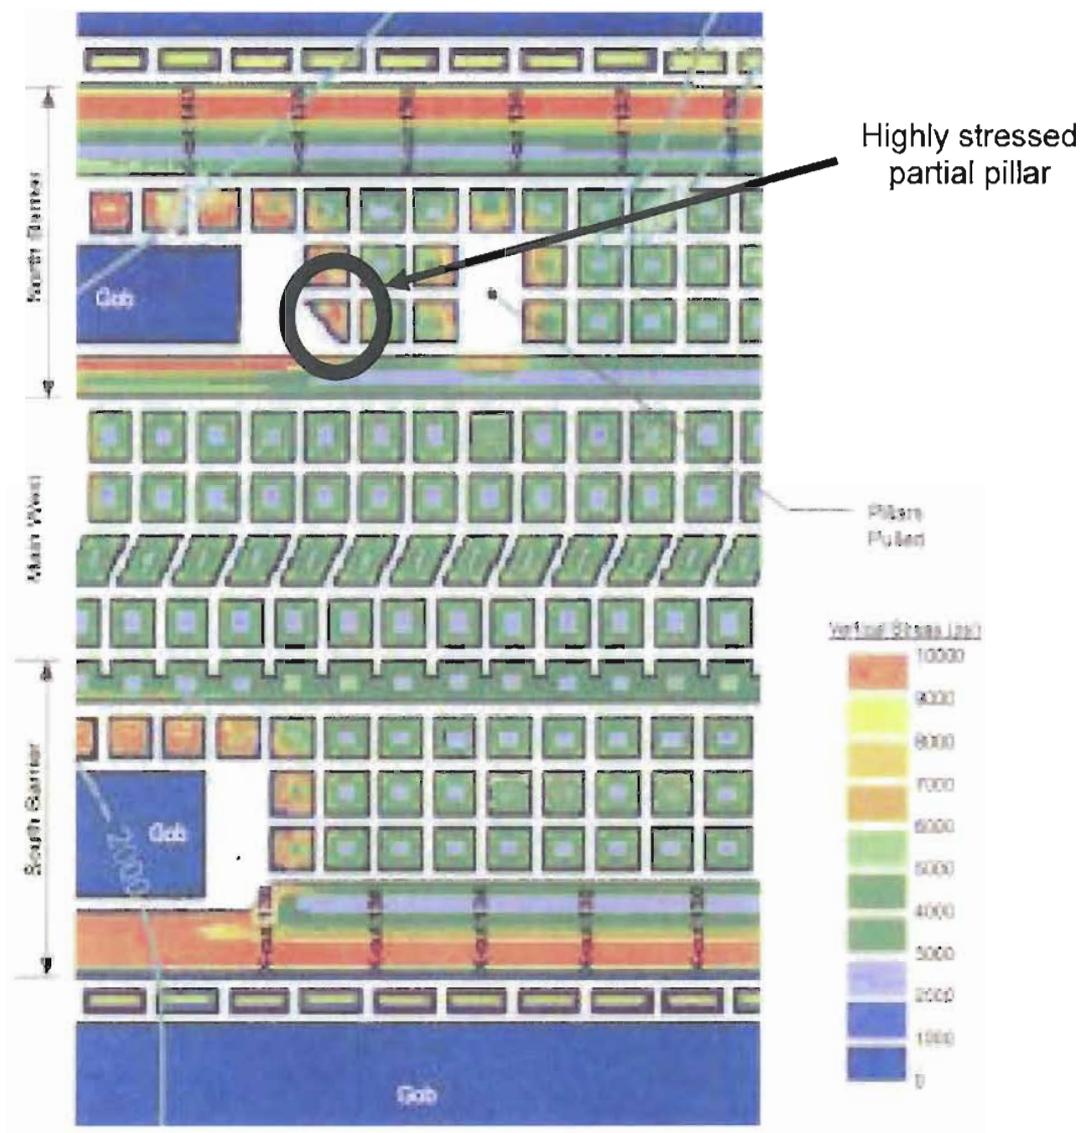
Figure 10. LaModel result shown on page 5 of the AAI report dated April 18, 2007, showing a very highly stressed, partially extracted pillar.

The high strength of the coal elements employed in the AAI models means that very little load transfer takes place within the models. The same figure 10 cited above shows that the abutment load from the longwall gobs is almost entirely dissipated within 100 ft of the gob edge, leading AAI to conclude that "stress conditions are expected to be controlled by the depth of cover and not by the abutment loads." Within the panels, the AAI models indicate that even yielded pillars carry very high loads. For example, on page 6 of the April 18, 2007 report, a half-extracted pillar within the North Barrier is shown as almost entirely "yielded." Yet the figure on page 5 (reproduced here as figure 10) seems to show that the same remnant is carrying stresses approaching 10,000 psi!

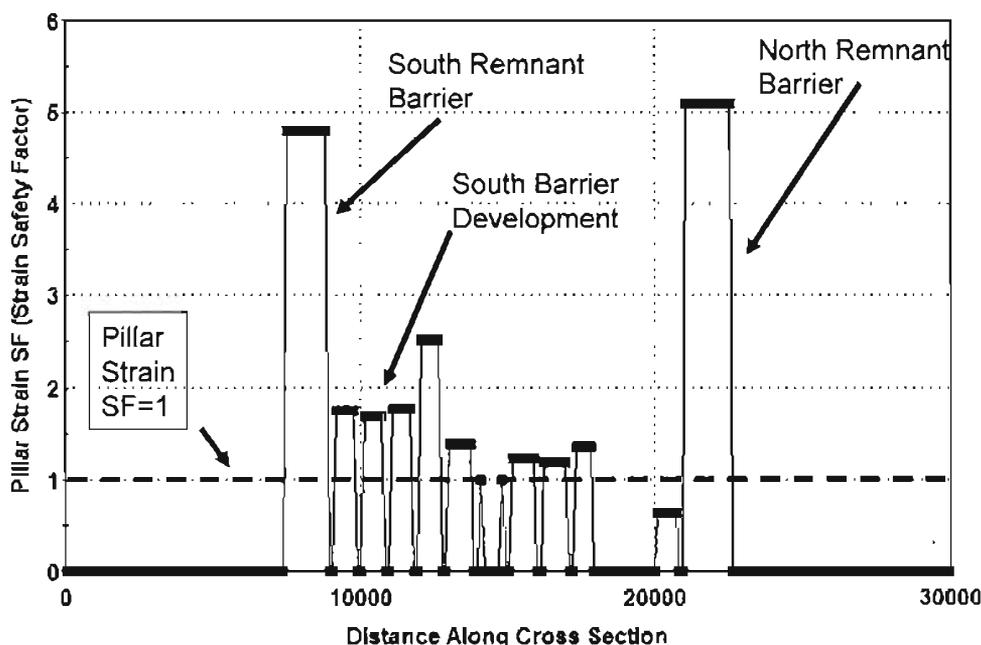
NIOSH has prepared a LaModel grid based on the geometry shown in figure 9. Models have been run to illustrate the effect of changing the coal strength on the results. LaModel provides cross-section plots of the “pillar strain SF,” which is a measure of pillar stability but is not directly comparable to the ARMPS SF. Figure 11 shows that when 1,640 psi is used for the in situ coal strength, none of the pillars in the South Barrier have yielded, and in fact they seem to be maintaining pillar strain SFs that are above 1.5. Reducing the in situ coal strength to 1,250 psi reduces the pillar strain SFs to approximately 1.0, which might be considered marginally stable. When the default value of 900 psi is used, all the pillars in the West Mains fail, and a portion of their load is transferred to the South Barrier development pillars. The calculated pillar strain SFs for the pillars in the South Barrier are all below 0.5, and are indicative of significant distress. Clearly the value selected for the in situ coal strength has a very large effect on the model results.

Figure 11. LaModel results with an in situ coal strength of 1,640 psi. Only one pillar has a LaModel pillar strain SF less than 1.0.

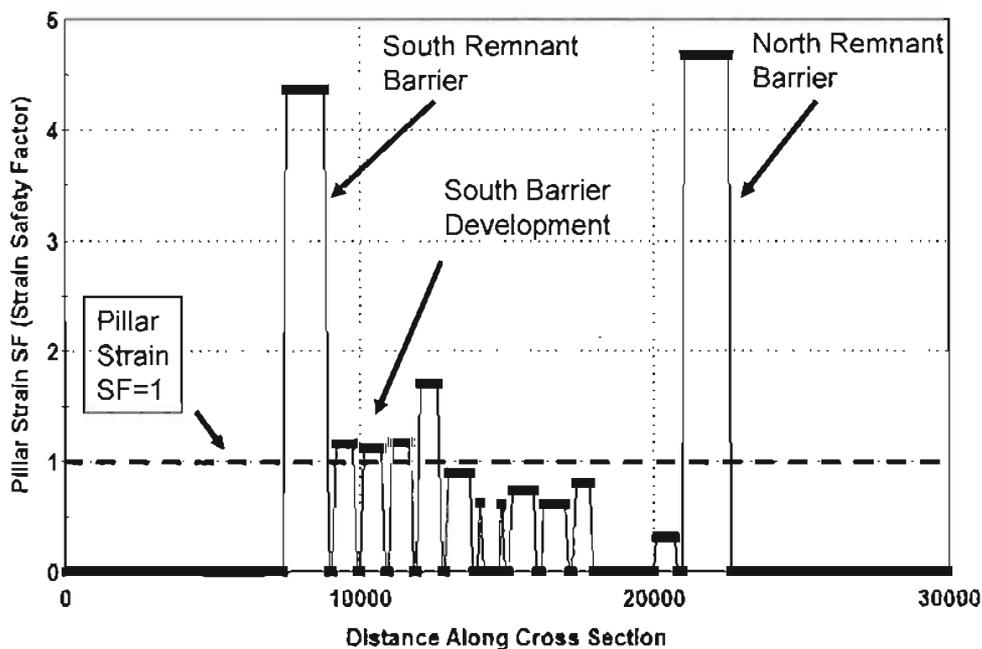
Figure 12. LaModel results with an in situ coal strength of 1,250 psi. Most pillars have LaModel pillar strain SFs of approximately 1.0.

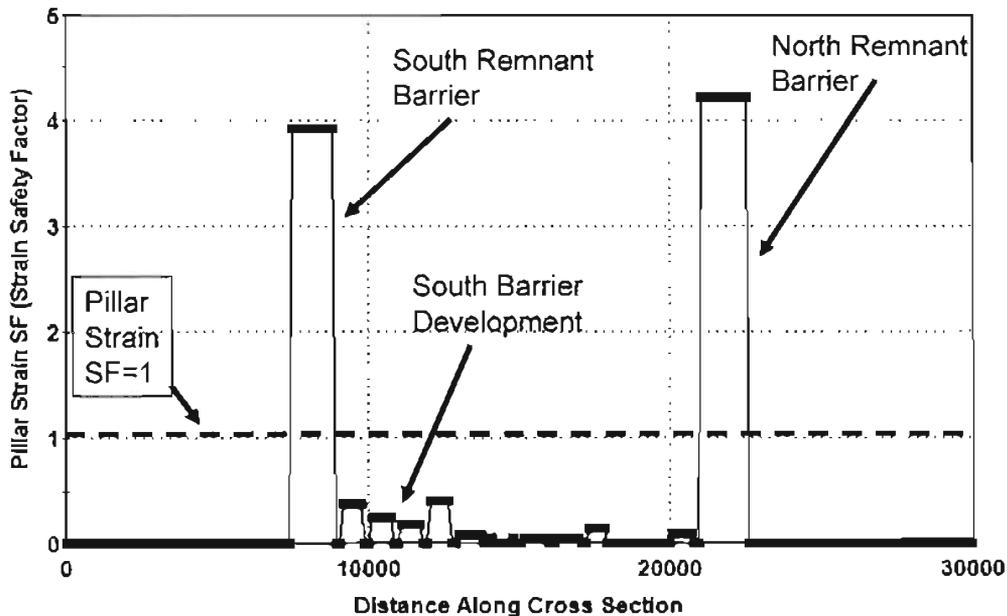
Figure 13. LaModel results using the default in situ coal strength of 900 psi. Most pillars have LaModel pillar strain SFs that are well below 1.0.

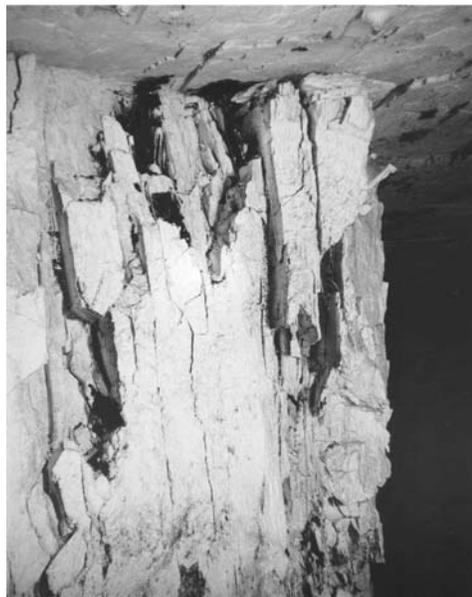
slabs of coal which can roll over without warning (figure 1). Some mines experiencing cleat related rib rolls have been compelled to orient entries 45° to the face cleat to maintain safer travelways in both entries and crosscuts. However, this orientation can cause the cleat to segment the pillar corners into large triangular columns of coal which tend to fail into the intersections. After experiencing these various conditions, some operators have opted to drive entries at a low angle (25-30°) with respect to face cleat in an attempt to minimize rib sloughage problems.

Figure 1. Vertical coal pillar slabs associated with face cleat.

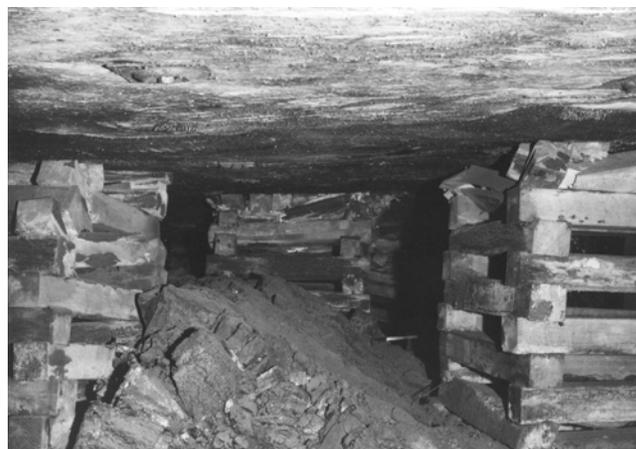
Floor failure can also be a deep cover operational issue. More typically, a competent roof tends to punch overstressed pillars into a weaker floor units causing heave in the roadways. Heave can be so extreme that equipment is not left in the working faces during idle shifts for fear of entrapment. Instances where it was necessary to use the continuous miners to regrade roadways for equipment clearance into the faces have also been documented. In one mine visited in southern West Virginia, approximately 4.5 ft of heave was observed just outby the pillar line in the 9 ft thick Beckley Coalbed (figure 2).

Figure 2. Excessive pillar line floor heave.
