There is general agreement that the immediate cause of the Crandall Canyon mine disaster was a large coal bump that occurred on the morning of August 6, 2007. Coal bumps, which are sudden, violent failures of highly stressed coal, have been a longstanding safety hazard in some mines in the Southern Appalachian, Colorado and Utah coalfields. Typically, bumps can occur when the roof and floor strata are strong and the mines are under deep cover. Bumps have caused many fatalities in past decades, and were the subject of intensive research by NIOSH and its predecessor agencies. The results of this research were transferred to the mining community, and much of it can be found at the NIOSH mining website. A landmark document describing the results of the research effort is Special Publication 1995-01, which is still considered the fundamental resource on the evaluation and control of bumps.

NIOSH has used ARMPS to evaluate, retrospectively, the complete sequence of events leading up to the bump on August 6. It must be noted, however, that the official investigation of the disaster at the Crandall Canyon mine has not yet been completed, so the data currently available for analysis is inc

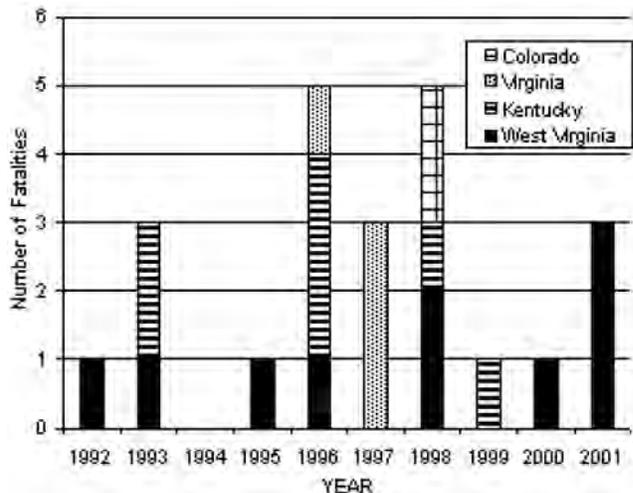
Figure 1. Pillar recovery fatalities, 1992-2001.

Figure 1 shows the location and the year each fatality occurred. All but one incident (a double fatality) were in the central Appalachian coalfields, where most retreat mining takes place.

One significant finding was that in nearly half of the pillar recovery incidents, no citations were issued. In another 5 cases, the mine was apparently following the minimum standards set forth in its approved Roof Control Plan, but was cited under 30 CFR 75.202(a) for failing to recognize and control hazardous conditions. Multiple violations, including not following the approved Roof Control Plan, were given in just 5 of the incidents. It seems, therefore, that the large majority of pillar recovery fatalities cannot simply be attributed to egregious violations of the law.

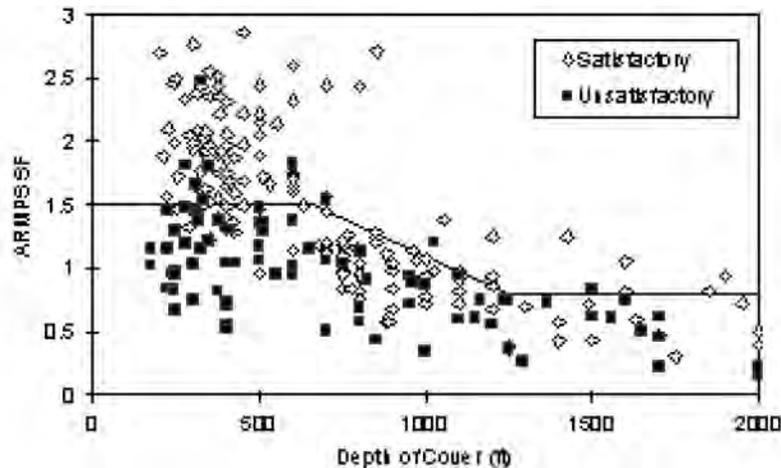
Figure 2. Suggested ARMPF Stability Factors, based on an expanded case history data base.

The Analysis of Retreat Mining Pillar Stability (ARMPF) program can be used to help size pillars to carry both development and abutment loads (Mark and Chase, 1997). ARMPF has been calibrated by back-analysis of hundreds of pillar recovery case histories. The database has recently been expanded to include more deep-cover cases, and new design guidelines have been proposed (figure 2 (Chase et al., 2002)).

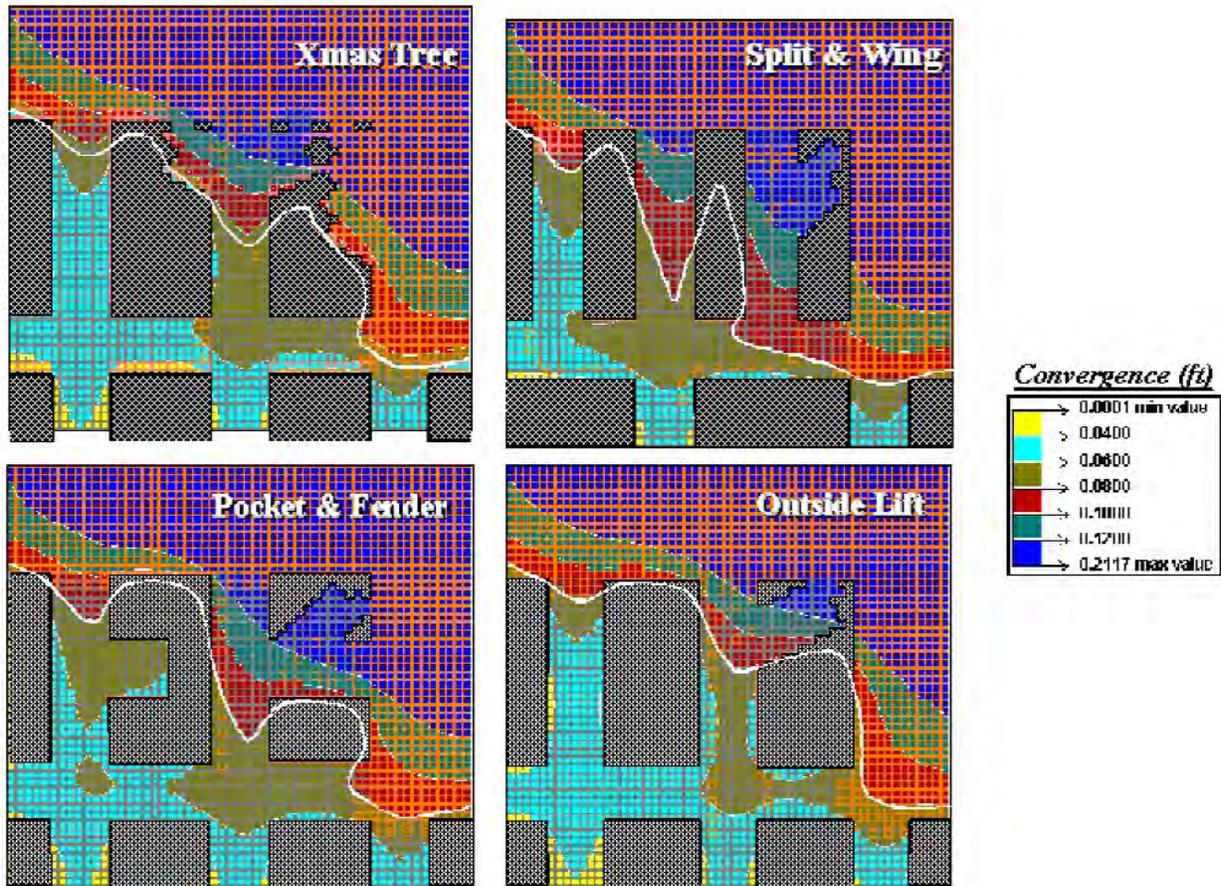
Figure 4. Roof convergence contours after several cuts. The 0.1 ft convergence contour is highlighted in white.

Figure 4 shows convergence contours for each of the four mining methods after roughly one-third of the coal has been extracted. The 0.1-ft convergence level has been highlighted for reference purposes. The convergence data generated represents gross movement of the main roof/floor and higher levels would be indicative of an increased potential for a roof fall.

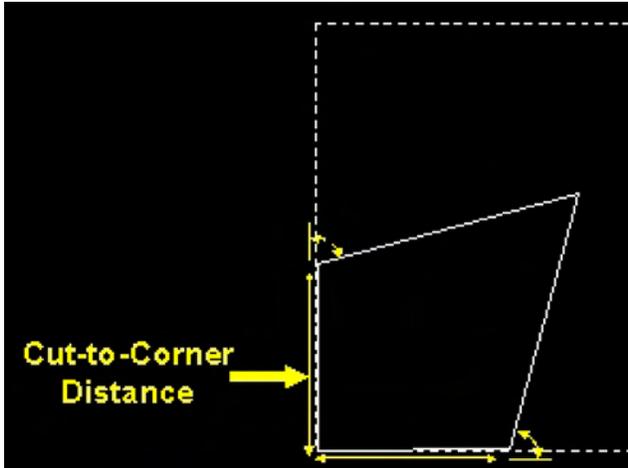
Figure 5. Cut-to-corner distances for the final stump.

For a stump to perform its function, it must not be cut any smaller than specified. Plans that indicate a set number of lifts can result in undersized stumps if the lift angles or actual pillar dimensions are different than expected. A better practice is to specify the cut-to-corner distance (figure 5). Foremen can use spray paint to mark the stump dimensions on the rib as a guide to the CM operator.

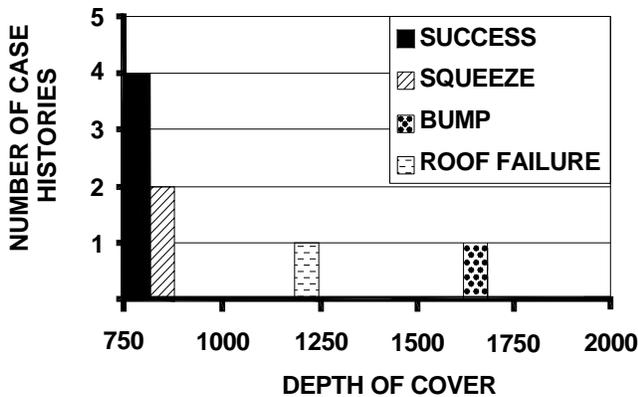
Figure 7. Deep cover weak roof rock data base.

When examining the data base (figures 7-9), it was readily apparent that there were only a handful of weak immediate roof rock cases. A total of 8 weak immediate roof rock cases were collected, and half of those were failures. In addition, the deepest successful weak roof rock case history occurred at approximately 850 ft. Given the fact that 60% of the deep cover mines were investigated during this study, the authors contend that the scarcity of weak roof rock case histories is indicative of the deep cover mine population, and does not

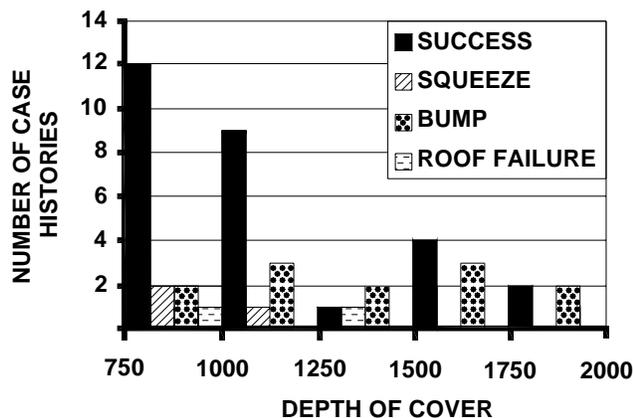
Figure 9. Deep cover strong roof rock data base.

The data base includes 16 bump and 14 squeeze failures. It should be noted that a majority of the squeezes (70%) occurred in the intermediate roof strength category, while 76% of the bumps happened under strong immediate roof rock conditions. Figures 7-9 also show that when the depth of cover was less than 1,250 ft, most

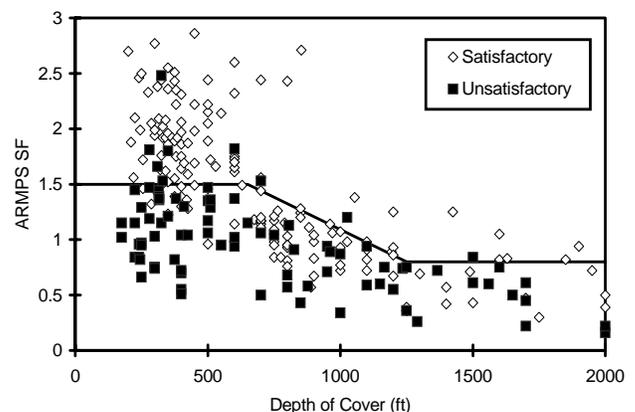
Figure 10. ARMPS case history data base.

Figure 10 compares the ARMPS SF's, depth of cover and outcomes for approximately 250 shallow, moderate and deep cover panel design case histories. Analyses indicate that an ARMPS SF of 1.5 or greater is appropriate where the depth of cover is less than 650 ft. As the cover increases from 650 to 1,250 ft, there seems to be a decreasing trend in SF's for both the successful and the unsuccessful cases. However, deeper than 1,250 ft, there does not seem to be any clear trend. These observations, combined with the fact that the most common failure mechanism shifts from a squeeze to a bump at approximately 1,250 ft of cover, seems to justify separating the data into two groups by depth. Logistic regression was used to analyze the two groups. The failures were weighted as two in order to balance the data. Because of the small number of weak immediate roof rock cases, they were added to the intermediate strength roof rock category.

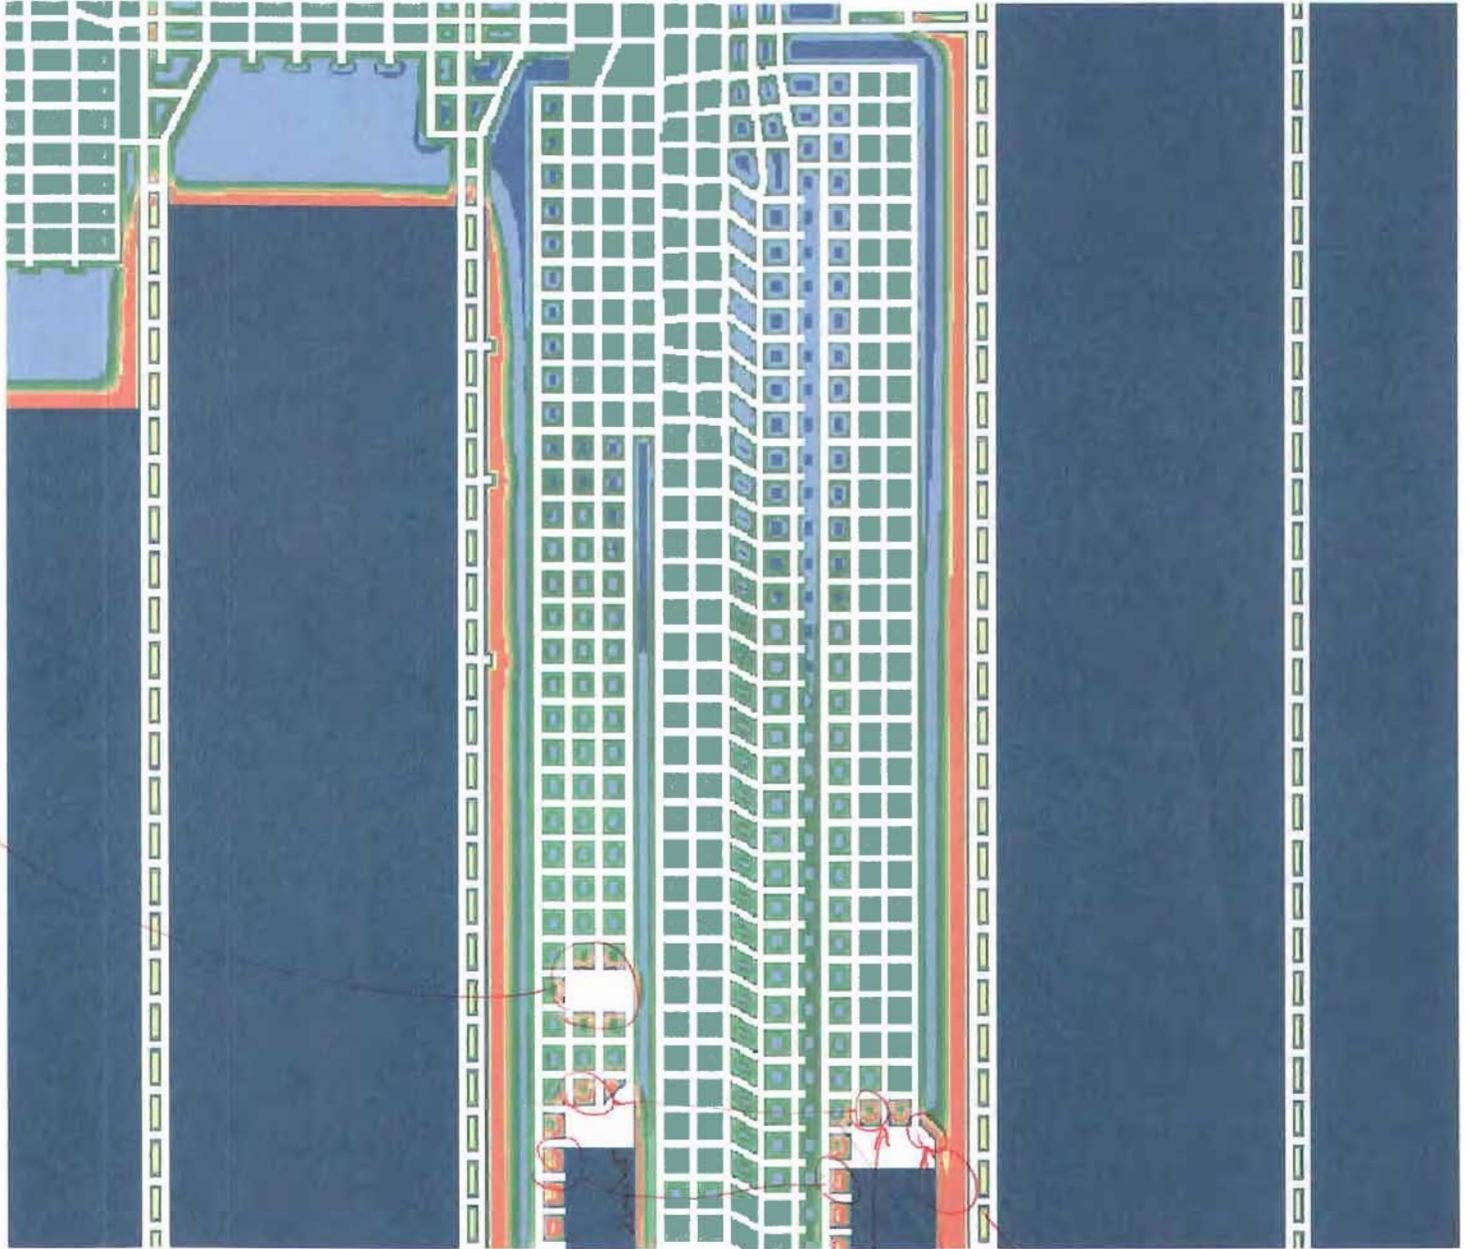
Worst 8

Not any worse
than retreat
line before (N side)

High 6
but main
danger will be
500' S of 4th
outlay

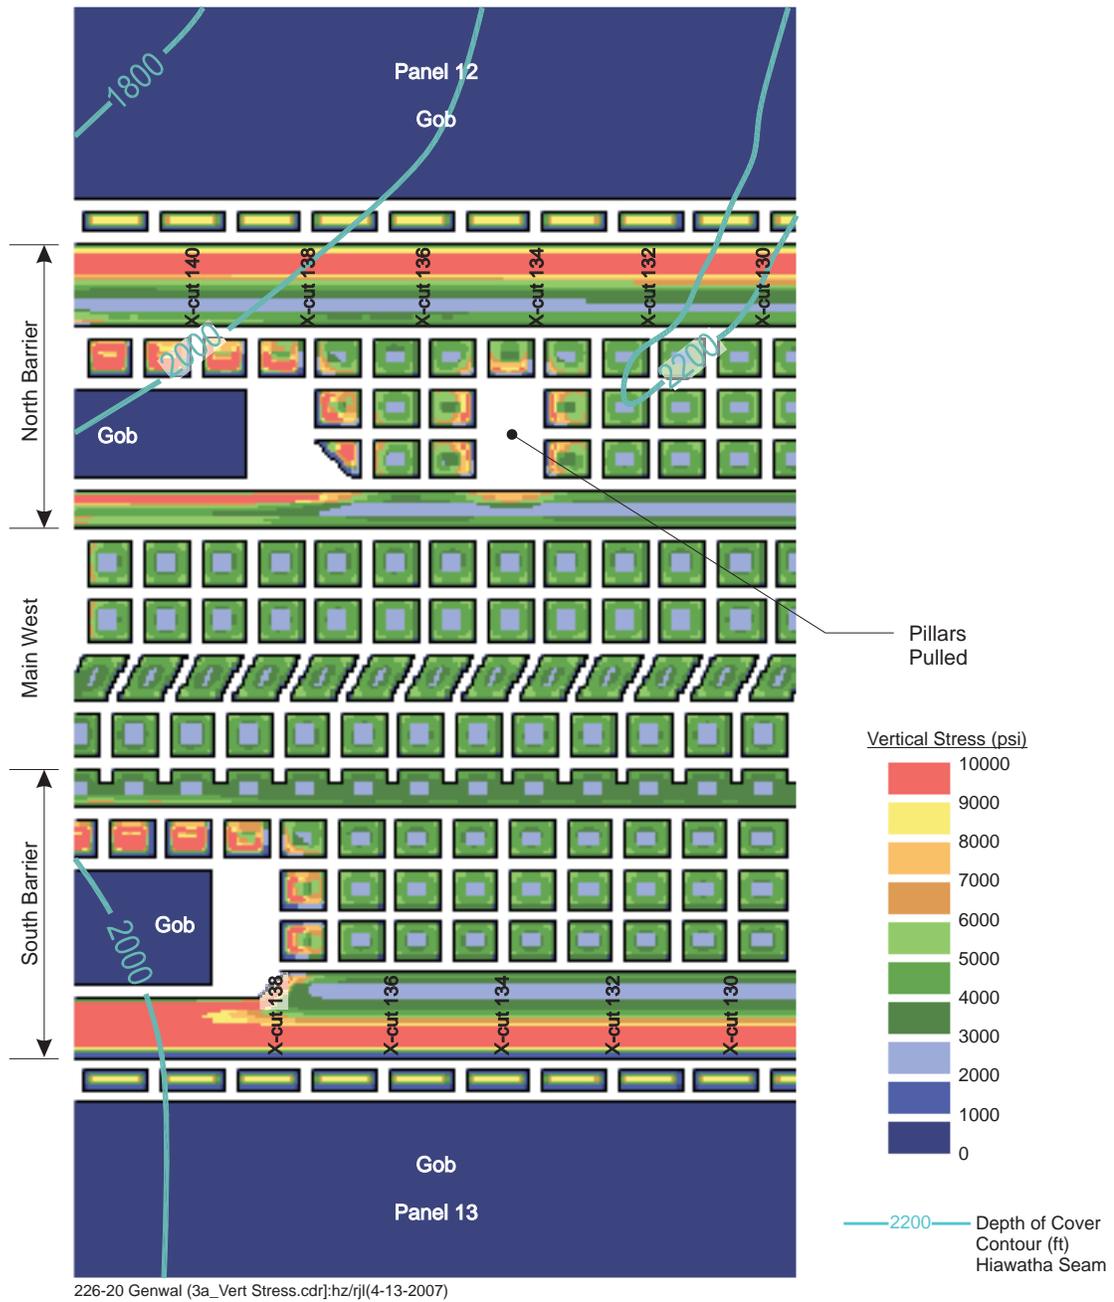
Figure 2. Modeled Vertical Stress—Existing Mining in the North Barrier and Optional Mining with 80-ft by 92-ft Pillars in the South Barrier

Model results show that high stresses were placed on the pillars from three contributing sources: (1) abutment loads from the main cave (inby XC 138), (2) abutment loads from the start-up cave (between XCs 134 and 135), and, to a lesser extent, (3) abutment loads from longwall Panel 12. Peak stresses were concentrated on the pillars located between the two caves (between XCs 135 and 138). Figure 3 shows significant yielding in these pillars indicative of overloading. Modeling suggests that the start-up cave contributed on the order of 5,000 psi additional stress to some parts of the surrounding pillars. This, coupled with the other abutment loads, is believed to have created a high stress region that allowed a localized bump in the pillars somewhere between XCs 134 and 135 to propagate to pillars over a much wider area.

Figures 2, 3, and 4 show stress, yielding, and convergence levels in the same sized pillars (80-ft by 92-ft¹) in the south barrier for ordinary retreat conditions, where no pillars are skipped. The figures show that high-stress conditions attenuate quickly away from the face and that protected conditions exist as close as one crosscut outby the face.

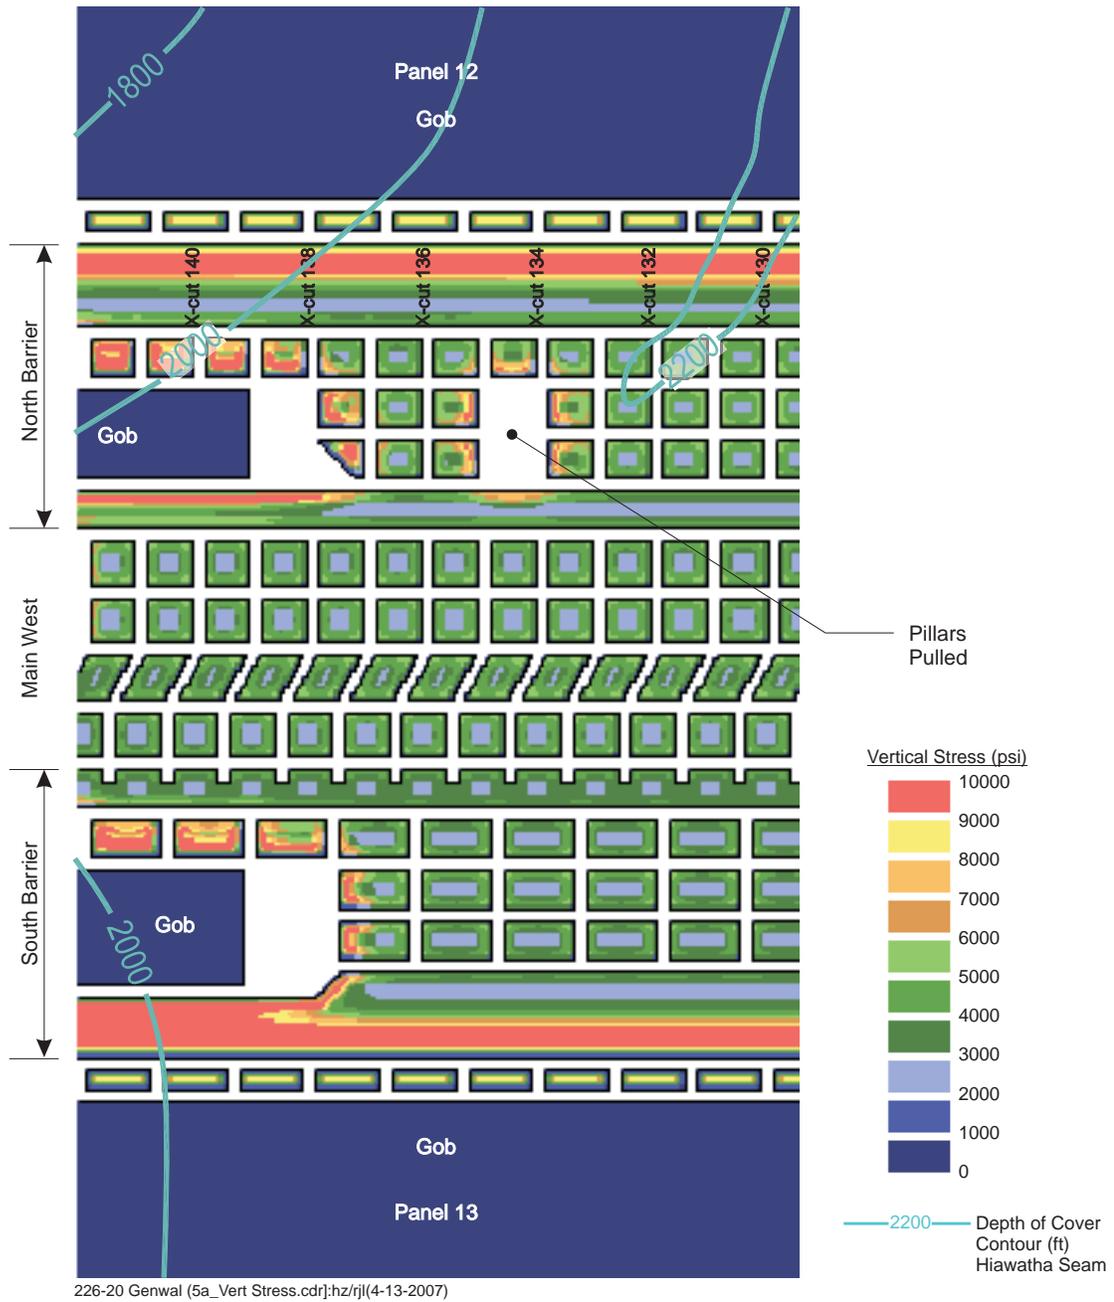
Figure 5. Modeled Vertical Stress—Existing Mining in the North Barrier and Optional Mining with 80-ft by 129-ft Pillars in the South Barrier

Figures 5, 6, and 7 illustrate the benefit of increasing pillar size from 80-ft by 92-ft¹ to 80-ft by 129-ft¹. The added 37 ft length, approximately equivalent to an extra full cut, increases the size and strength of the pillars' confined cores, which helps to isolate bumps to the face and reduce the risk of larger bumps overrunning crews in outby locations. For conservatism, a lagging cave was also assumed in the south panel. Plans are to slab the south barrier to a depth of about 40 ft. The wider span is expected to improve caving conditions compared to the north panel and reduced concentrated loads at the face.
